Dry stone walls as sediment traps: example from Rydal

Wilson, P., & Lord, T. (2018). Dry stone walls as sediment traps: example from Rydal. *Proceedings, Cumberland Geological Society*, 8(4), 477-491.

DRY STONE WALLS AS SEDIMENT TRAPS: EXAMPLE FROM RYDAL

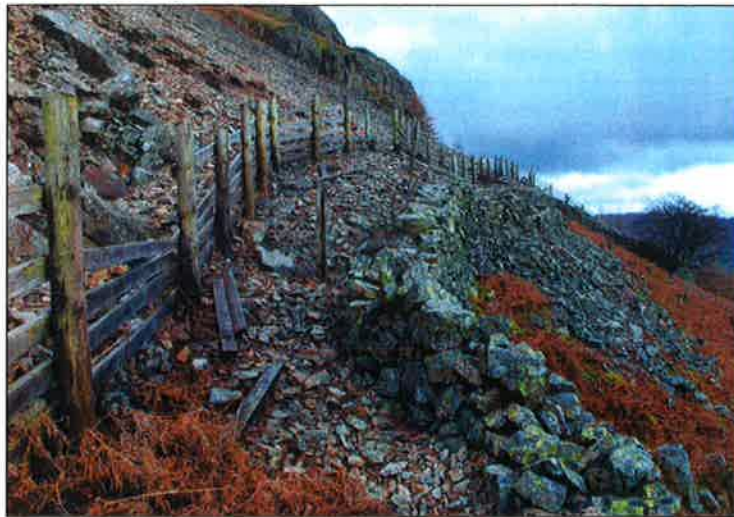
Figure 1. Wall above the Old Dungeon Ghyll Hotel in Great Langdale overtopped by downslope movement of talus.

In some Lake District valleys, debris/colluvial fans have accumulated against the upslope side of dry stone walls that are aligned across slope, in mid-to-lower slope locations. As a consequence, the fans are perched on the valley sides rather than being at the slope foot. Examples of this phenomenon can be seen on the upslope side of walls that traverse the hillside at ~170-190 m above sea level (asl) between the Old Dungeon Ghyll Hotel and Raven Crag in Great Langdale (Fig. 1): "walls have acted as temporary dams to this down-slope creep of fan material" (Barringer, 1970, p.43). These walls are regarded as 'Statesmen Walls' constructed between the late 16th century and ~1750 AD (Lund & Southwell, 2002) and therefore fan accumulation to the full height of the walls (~1.5 m) has taken a maximum of ~300-350 years. Fan surface debris consists of unvegetated angular clasts and is continuous upslope with talus. At these locations, the rate of downslope movement may have been accentuated during the last 100 years or so as a consequence of human traffic along footpaths that cross the talus and lead to the rock climbing routes on Gimmer Crag, Middlefell Buttress and Raven Crag.

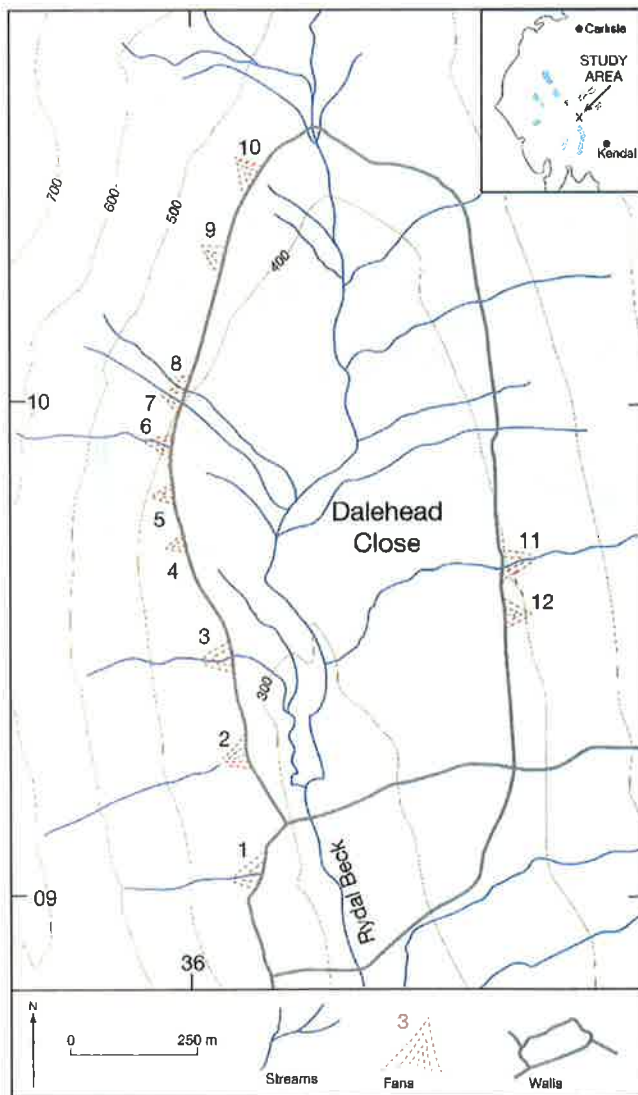
Figure 2. Map of Dalehead Close, Rydal, showing locations of the debris fans. Note that fans are shown schematically rather than at their true scale. Contours are in metres and grid line co-ordinates are given in the margins.
© Crown copyright Ordnance Survey. All rights reserved.

Dalehead Close (Grid Reference NY 363096; Fig. 2) is the name of the northernmost enclosure in the upper Rydal valley. It extends north - south for 1.4 km, has a maximum width of 0.65 km, and encompasses 0.75 km² of the valley floor and lower slopes of Great Rigg (766 m), to the west, and Dove Crag (792 m), to the east. The enclosure rises from 300 m asl at its

Brief details of each fan as recorded in October 2016 are provided below. The fans are numbered 1 - 12 and their locations are indicated on Fig. 2.

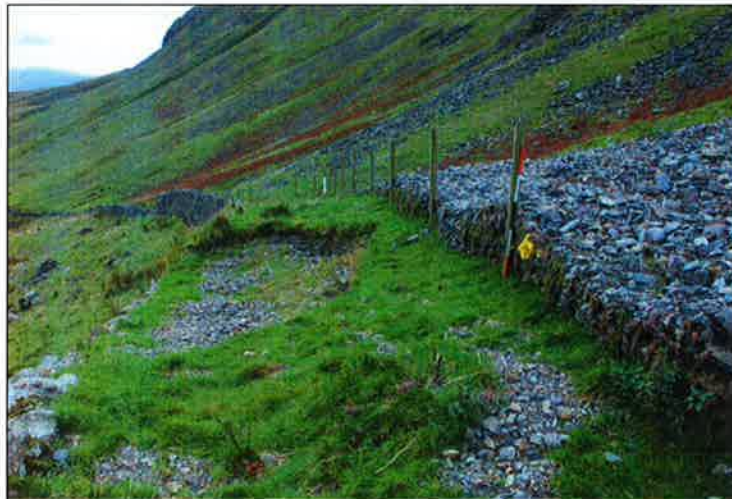
Figure 5. The surface of Fan 6 with recent debris from the December 2015 storms trapped against the fence. The vegetated surface of the fan to the left of the fence is slightly higher than the wall.

Fan 6: This fan, at Grid Reference NY 359099, has a cover of recent debris, 0.5 - 0.6 m in thickness, trapped by the post and wire fence (Fig. 5). Prior to this input of sediment, the vegetated fan surface stood slightly above the capstones of the wall, which were obscured for a distance of 20 m. The recent debris extended for 22 m along the fence and in plan it tapered upslope for 20 m to the foot of an incised channel. The debris is probably a product of the December 2015 storms. Wall height south and north of the fan is 1.3 - 1.6 m.

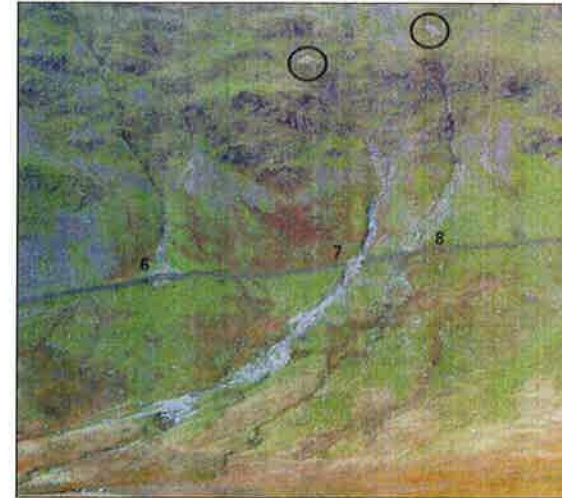
Figure 6. Fans 6, 7 and 8. Shallow landslip scars (ringed) are present near the heads of the gullies that feed Fans 7 and 8. Prior to December 2015 debris accumulation upslope of the wall at Fans 7 and 8 was very limited in its extent and thickness.

Fans 7 and 8: These two fans are adjacent at Grid Reference NY 360100 (Fig. 6). Prior to the storms of December 2015 water from both gullies was able to pass through gaps in the wall and carry fine sediment to the valley floor; the field evidence suggests that any pre-existing fans were of limited extent and thickness. As a consequence of the storms the wall was breached for lengths of 9 m (Fan 7) and 3.5 m (Fan 8), and at the latter site some debris remains level with the top of the wall adjacent to the breach. At both places the wall has been rebuilt and water is free to flow through as before.

Immediately upslope of Fan 7 is an incised channel 1 - 2 deep, and near the head of each gully there is a shallow landslip scar (Fig. 6). It is inferred that the saturated debris from these landslips was transported rapidly downslope and caused much coarse sediment to be trapped against the wall, and destroyed two short segments of the wall where the streams passed through.

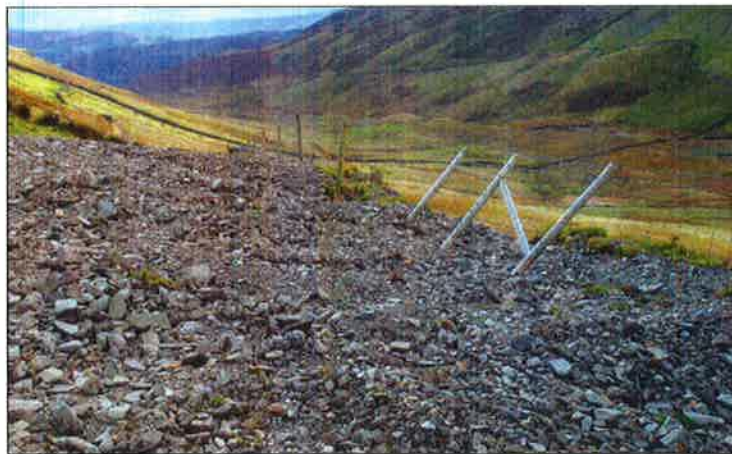
Figure 8. The debris of Fan 11 is level with the top of the wall and has spilt over into the enclosure. It has also disturbed the fence that was built to maintain the boundary and prevent sheep from jumping into the enclosure.

Fans 11 and 12: These adjacent fans are on the east side of Dalehead Close (Grid Reference NY 366096) and on both the debris is unvegetated. Fan 11, fed by a single incised stream channel, has obscured the 1.5 m high wall for a distance of 18 m (Fig. 8). In contrast Fan 12 is a compound area of debris brought downslope by several shallow stream channels. Debris from these channels extends alongside the wall for ~150 m and in the past may have overtopped or breached the wall. The present wall in this area looks to have been rebuilt recently but does not rise more than 1 m above the debris. While both fans are likely to have had debris added to them during December 2015, they were first recorded as active fans in 2004 by one of the authors.
